# **U.S. 301 PROJECT DEVELOPMENT**

## **DETERMINATION OF ELIGIBILITY REPORT**

**St. Georges, Pencader, and Appoquinimink Hundreds,  
New Castle County, Delaware**

## **Volume II: Narratives and CRS Forms for N05191 to N13309**

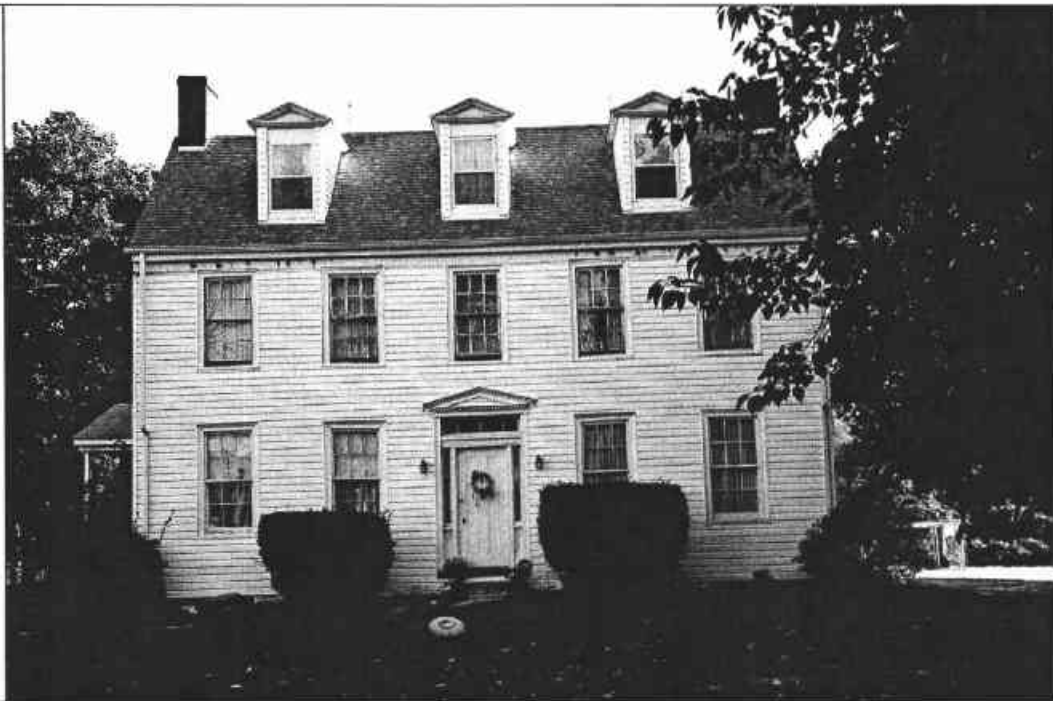
N05191. Photograph 1: S.H. Rothwell House, dwelling, west elevation, view to east. Note original door surround, fenestration pattern, chimneys, doors and windows.

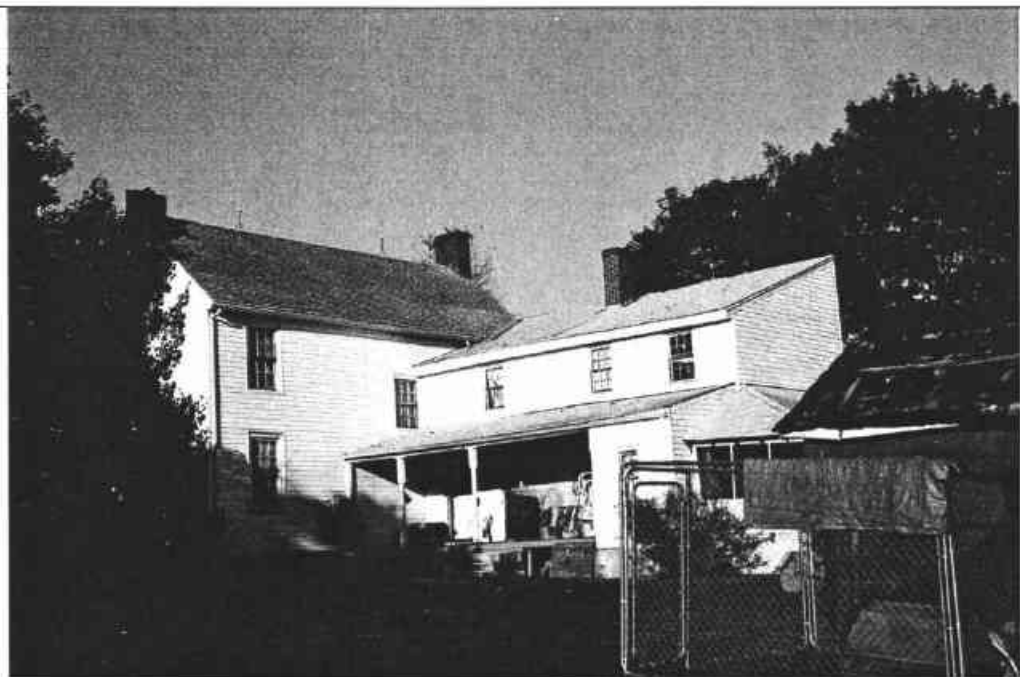
N05191. Photograph 2: S.H. Rothwell House, east and south elevations, view to northwest. The original block may be located in the rear flounder ell.

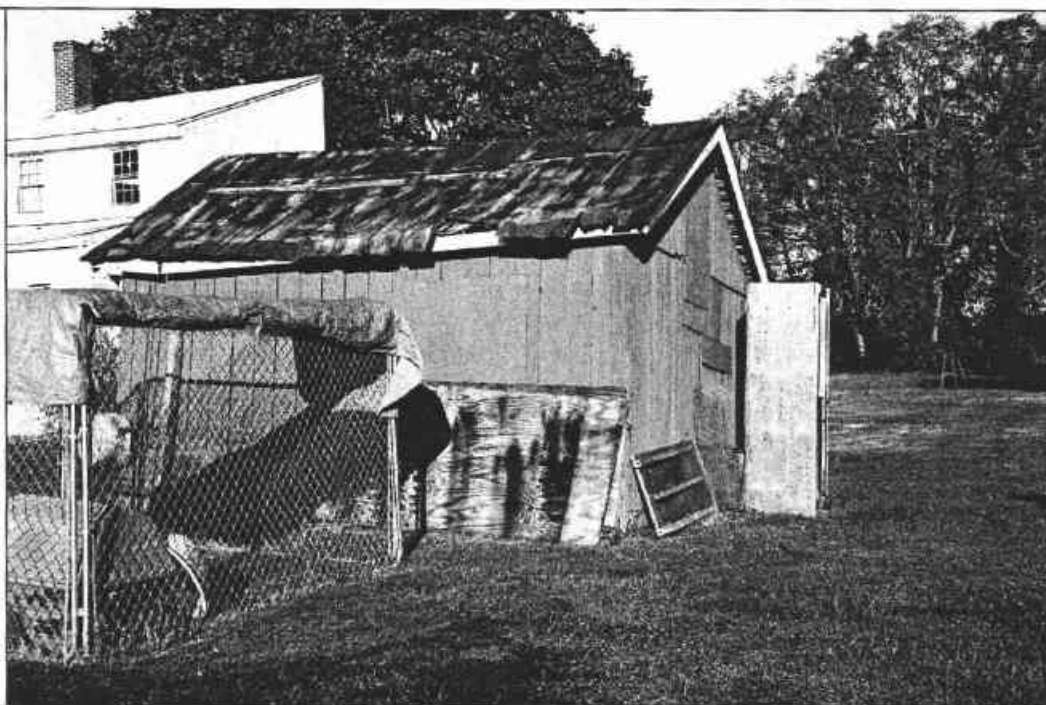
N05191. Photograph 3: S.H. Rothwell House, shed, east and south elevations, view to northwest.

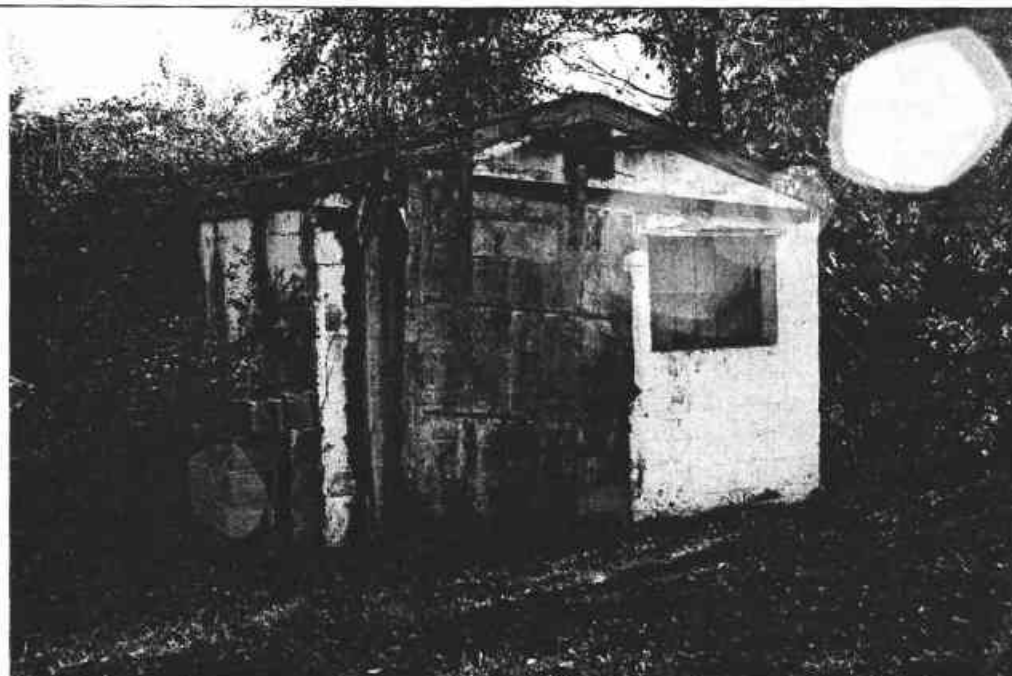
N05191. Photograph 4: S.H. Rothwell House, milkhouse, north and west elevations, view to southeast.

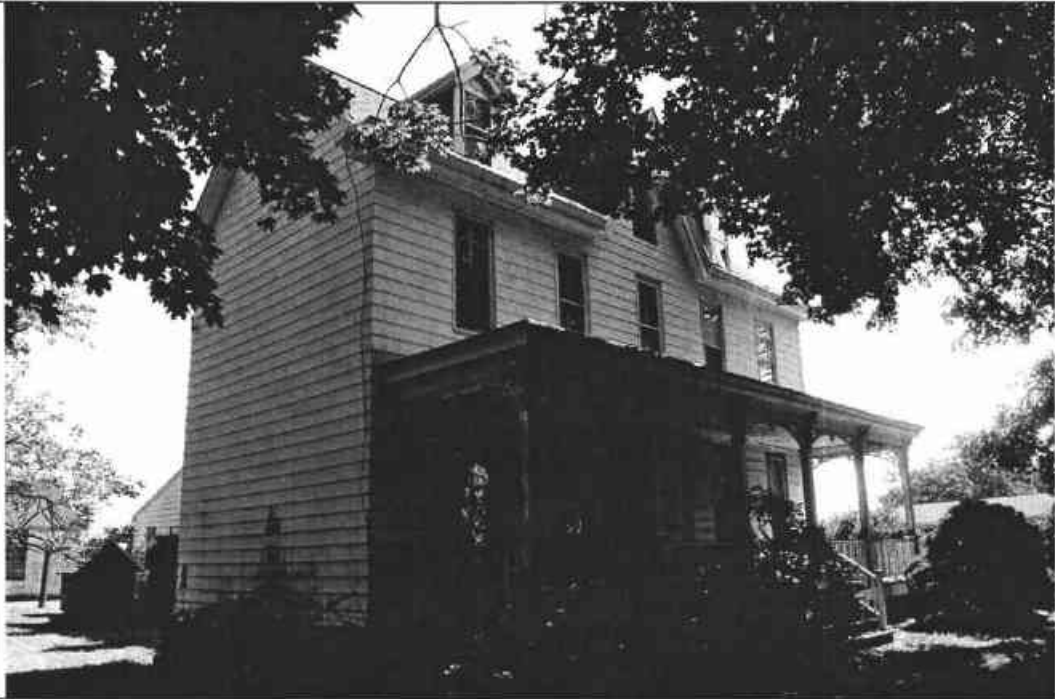
N05195. Photograph 1: South and west elevations of main dwelling to the northeast. Note decorative brackets and scrollwork at the top of the front porch.

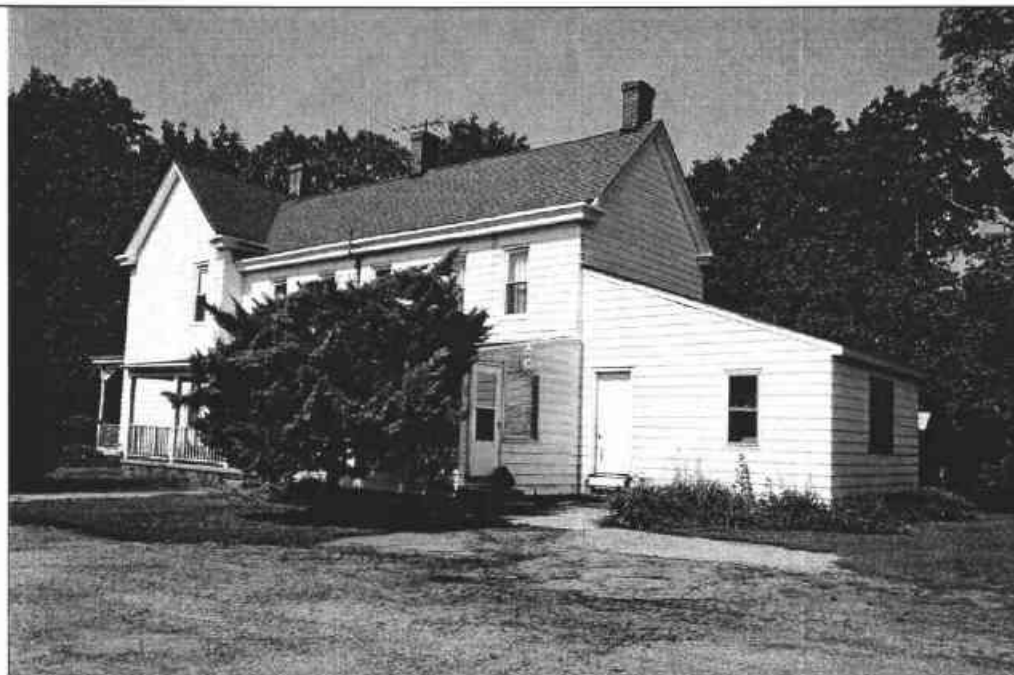
N05195. Photograph 2: East and north elevations of the main block, rear ell, and lean-to addition of the main dwelling, to southwest.

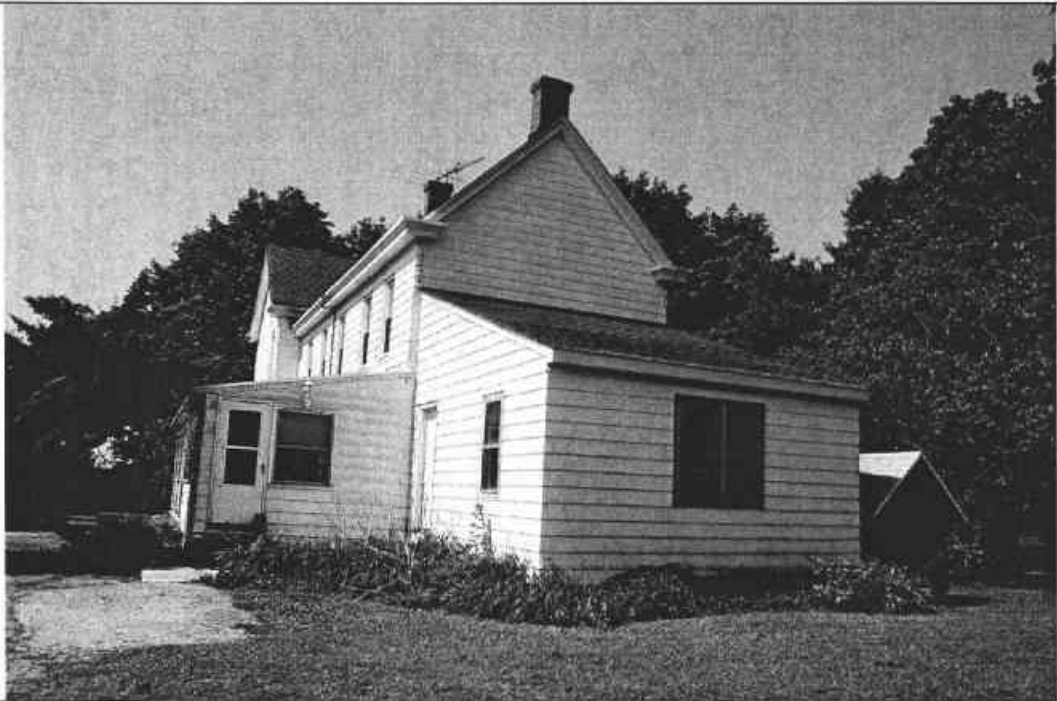
N05195. Photograph 3: North elevation of rear ell and lean-to addition to the southwest. Note partially enclosed east elevation porch.

**trim** Wood and aluminum
- 4) **Porch(es)** Wood frame porch on cinder block foundation extends length of rear ell; has  
     concrete floor, square wood posts, simple wood balustrade, shed roof covered with asphalt;  
     northernmost section of porch is enclosed and clad with aluminum siding

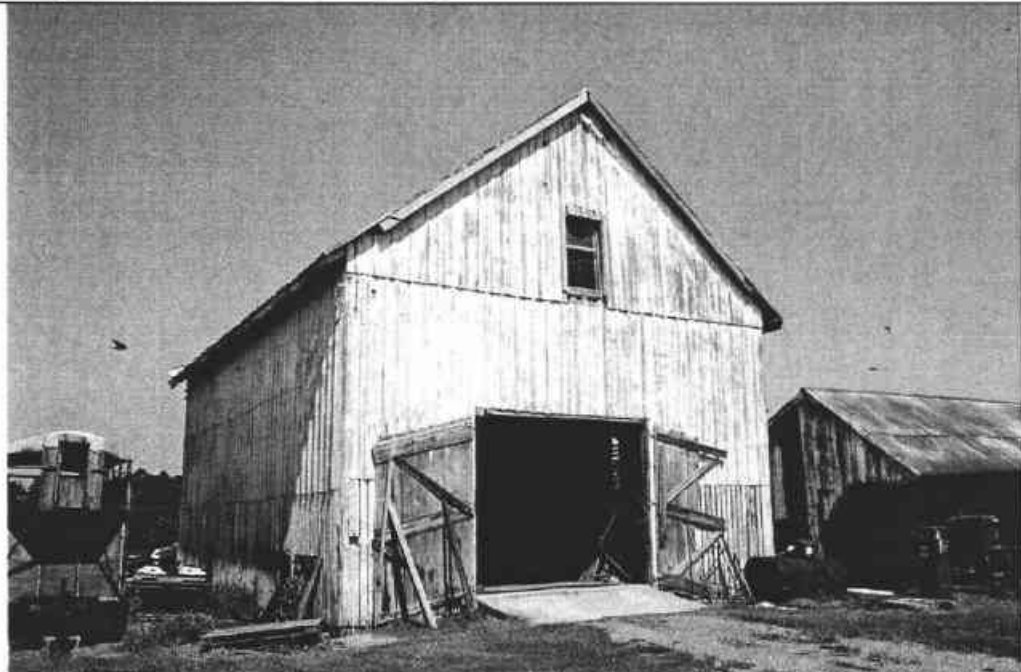
N05195. Photograph 4: East and south elevations of corncrib/granary, to northwest. Note poured concrete ramp leading into first floor entrance.

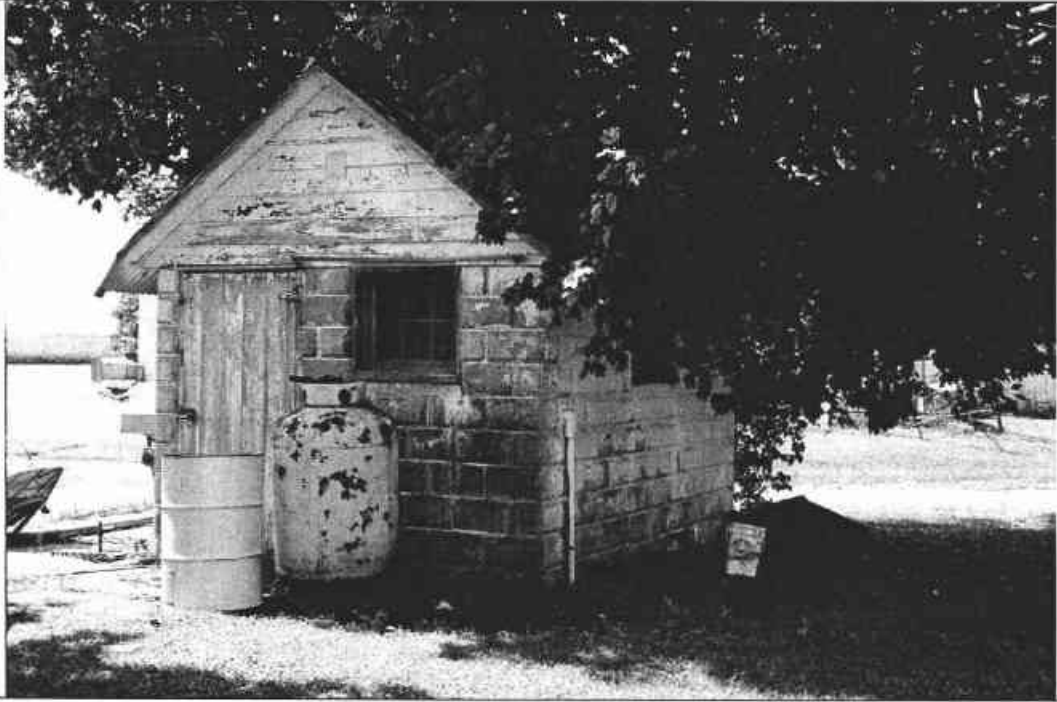
N05195. Photograph 7: West and south elevations of concrete block milkhouse, to northeast.

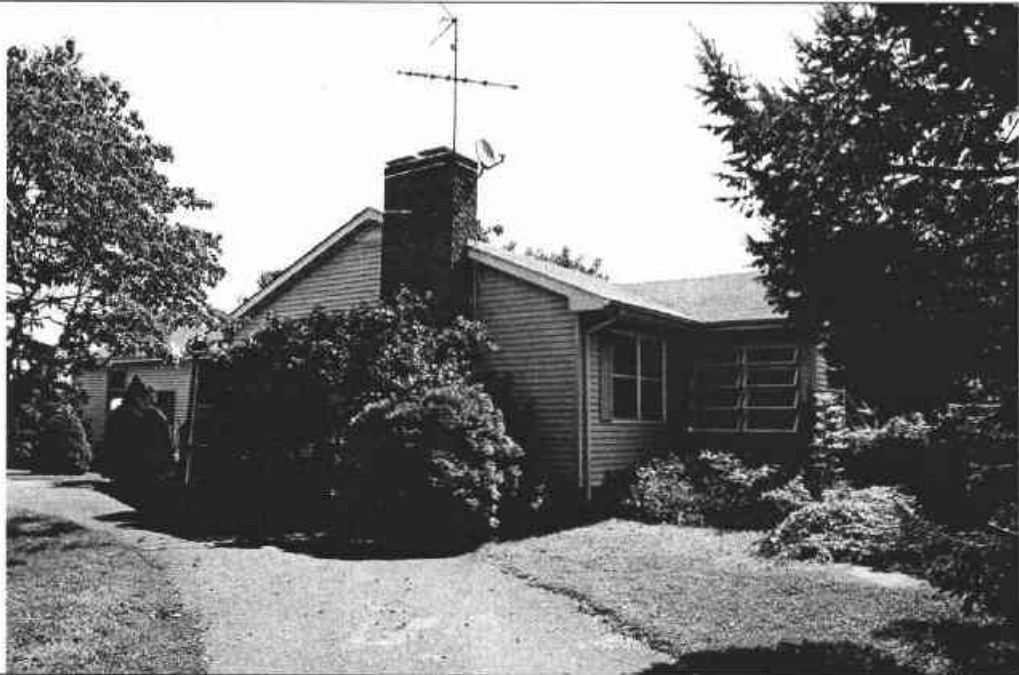
N05195. Photograph 8: South and west elevations of modern dwelling, to northeast.

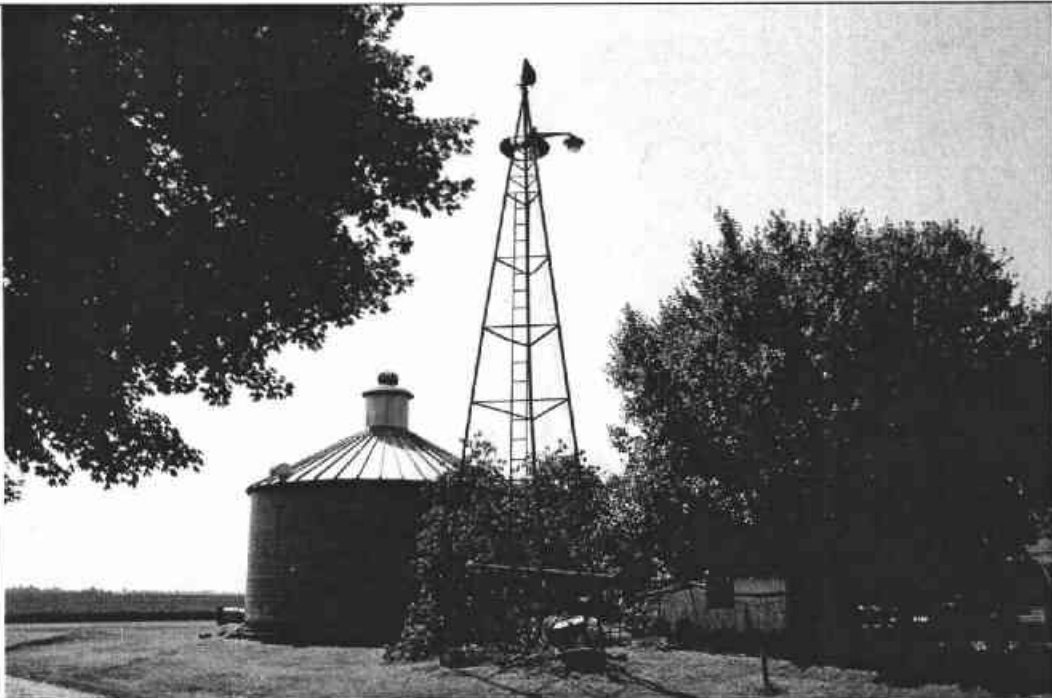
N05195. Photograph 9: View of windmill and modern grain bin located to northeast of main dwelling, to north.

6. CURRENT CONDITION: excellent ☐ good ☐ fair ☐ poor ☒
7. DESCRIPTION (describe the structure as completely as possible):
- a) Overall shape Cone-shaped with windmill mechanism on top  
height Approx. 50'.  
length N/A  
width Approx. 6' at base to 1' at top  
Windmill blades are missing

- 1 - structure is damaged at base, so entire structure is slanting
- 2 - blades are missing, but windmill mechanism is in place at top
- 3 - metal ladder on NW elevation
- 4 - small, round wood platform at top of structure
- 5 - thin metal cables criss-cross each elevation to provide additional support
- 6 - water pump adjacent to SE corner

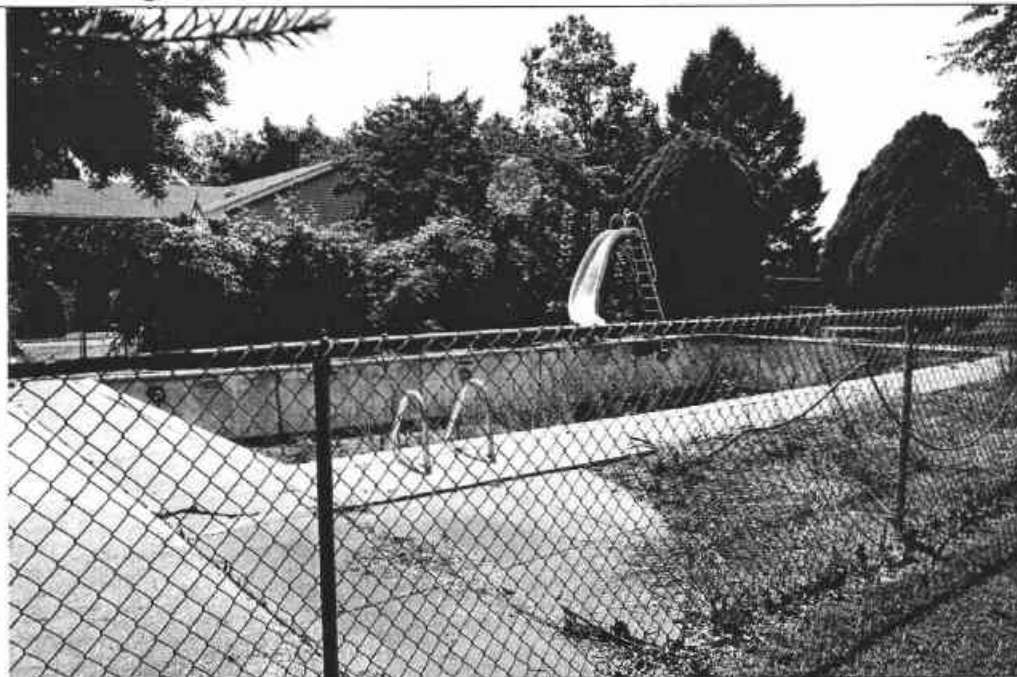
N05195. Photograph 10: View of concrete in-ground pool located directly east of main dwelling, view to east.

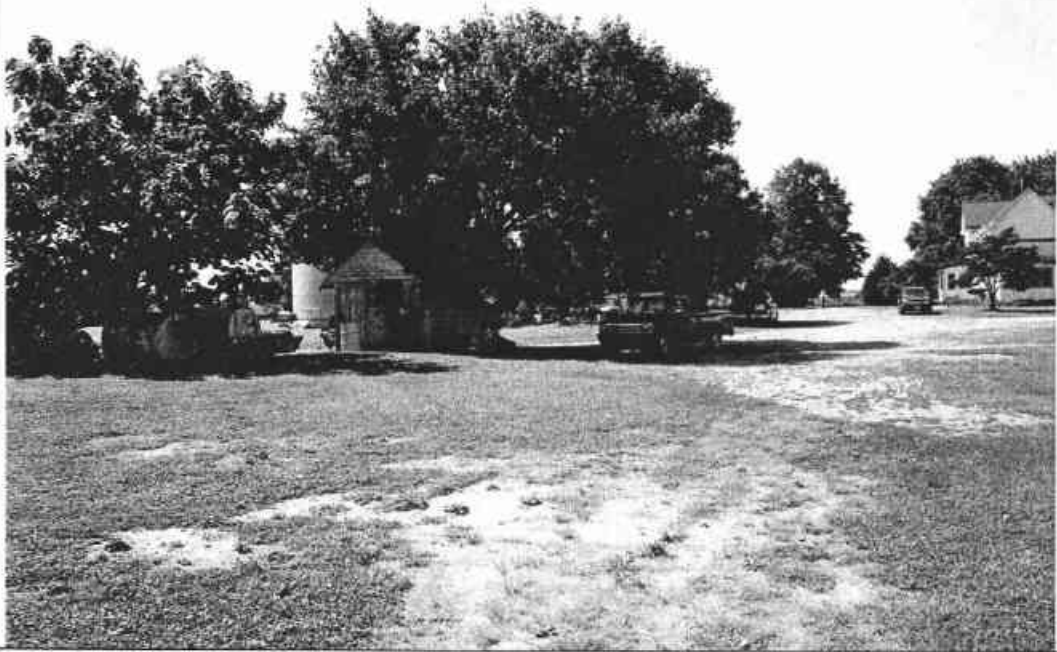
N05195. Photograph 11: West and north elevations of milkhouse, to southeast. Former location of barn is to the left.

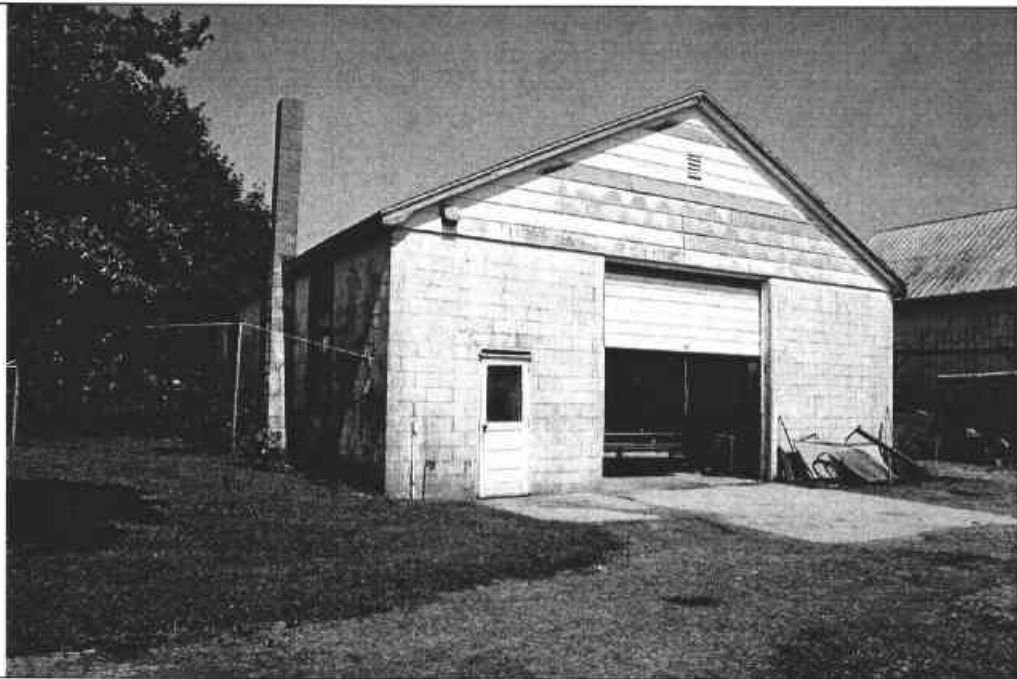
N05195. Photograph 12: South and east elevations of workshop, to northwest.

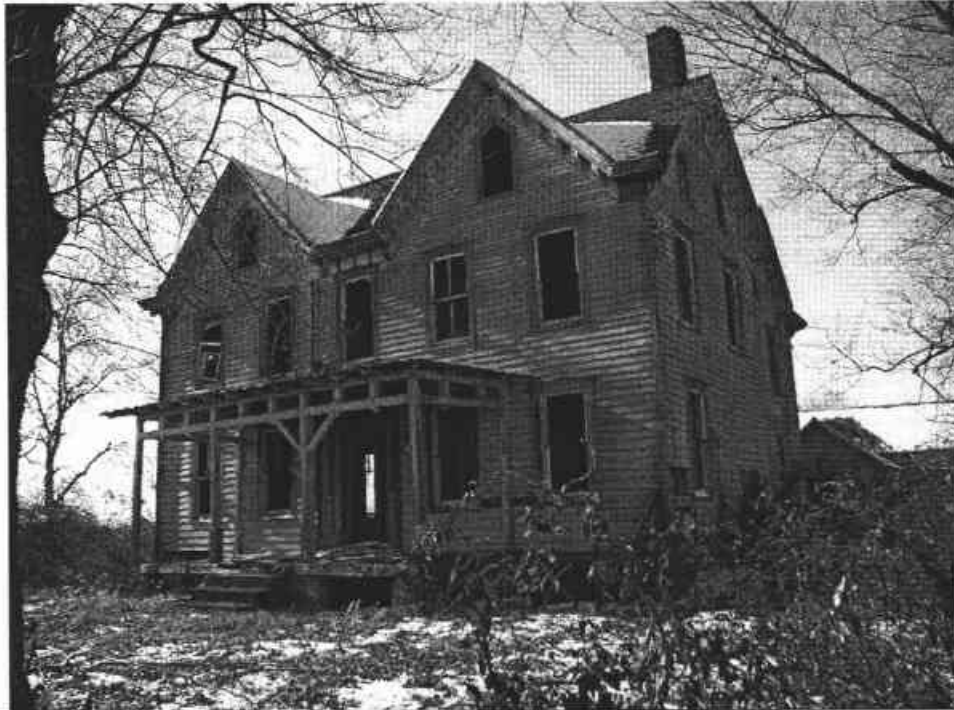
N05196. Photograph 1: Dwelling, east and north elevations, view to southwest. Note missing window sash, door, and porch details.

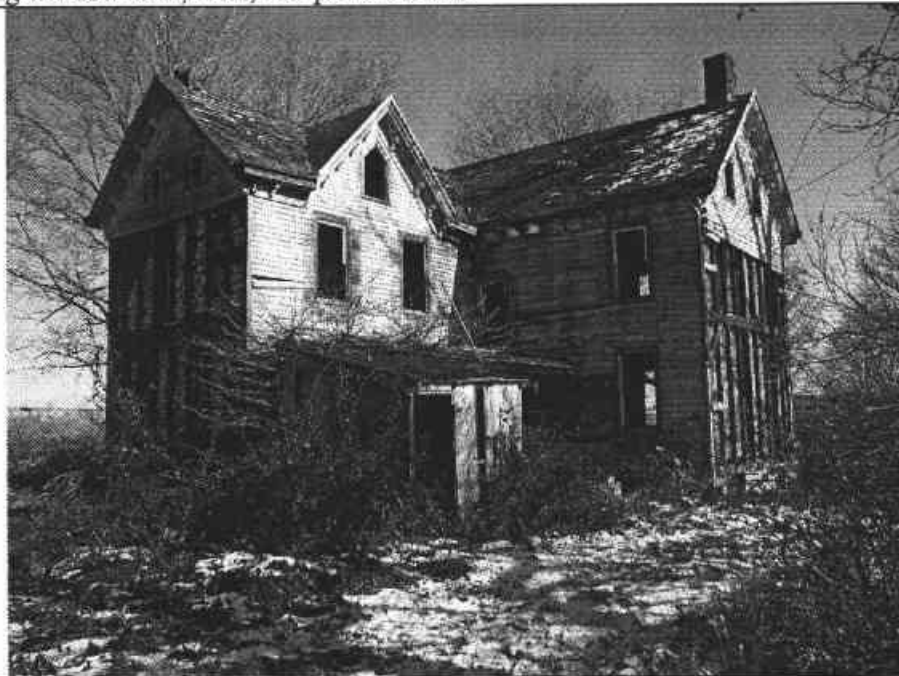
N05196. Photograph 2: Dwelling, west and south elevations, view to northeast. Note missing clapboard on the gable ends.

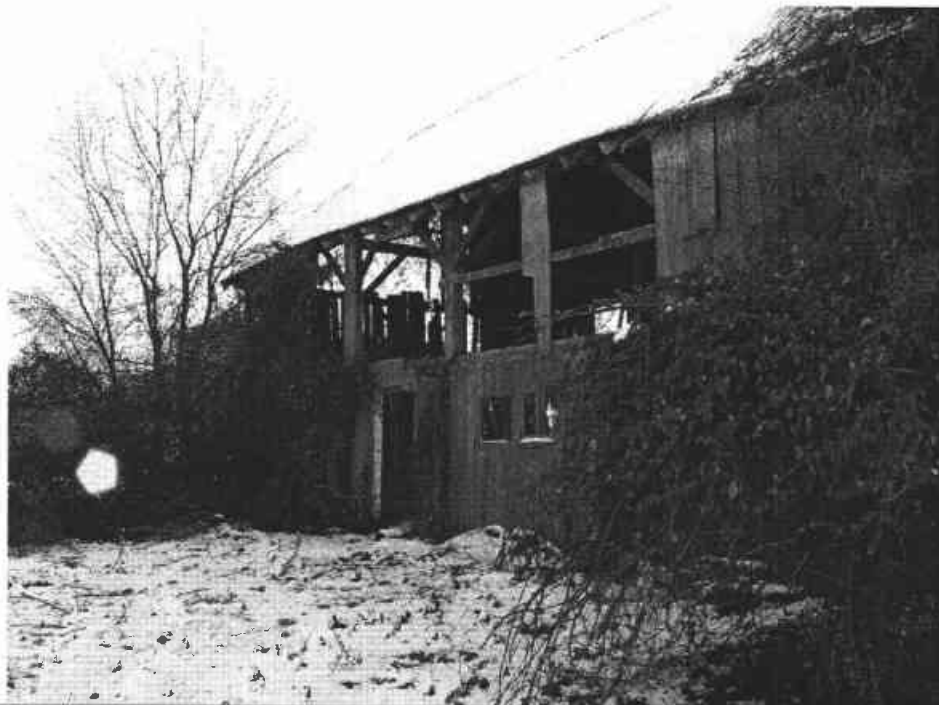
**N05196. Photograph 3: Dairy barn 1, north elevation, view to southeast. Note missing vertical wood planks.**

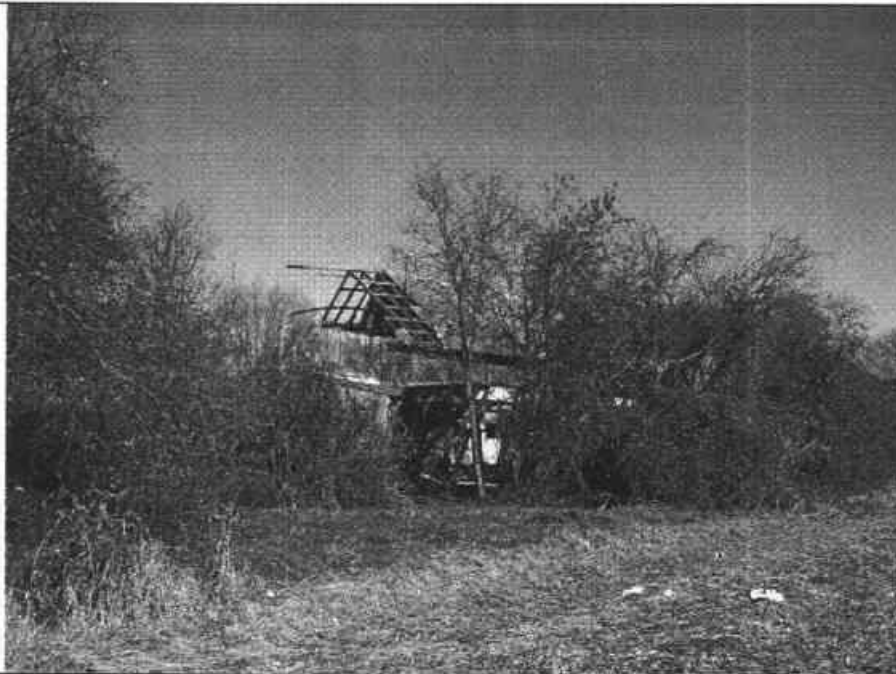
**N05196. Photograph 4: Dairy barn 1, south elevation, view to northeast. Note western portion of barn has collapsed.**

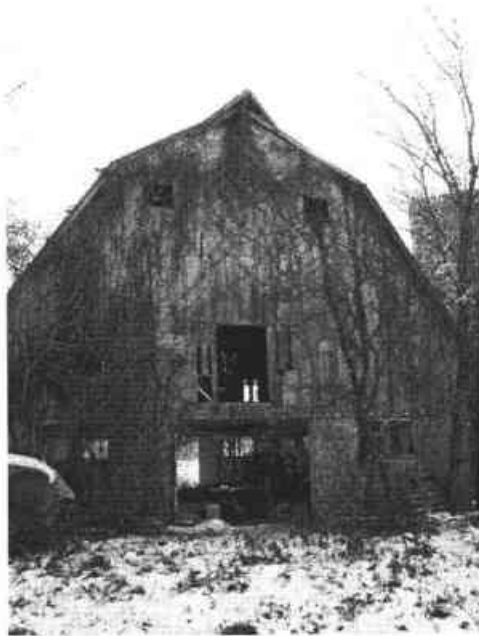
N05196. Photograph 5: Dairy barn 2, north elevation, view to south.

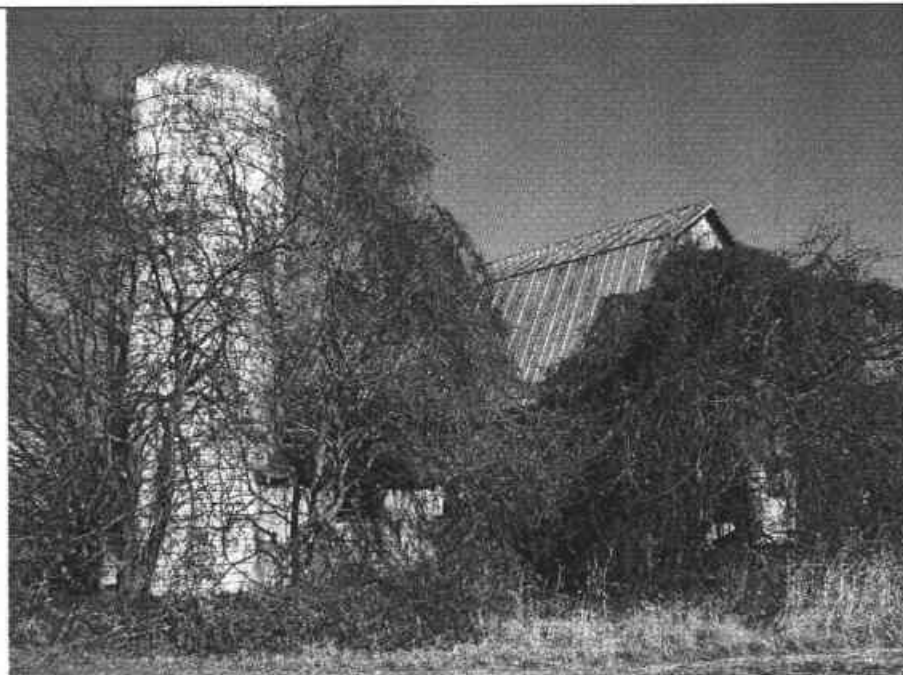
N05196. Photograph 6: Dairy barn 2, south and west elevations. Note silo and concrete block feed house.

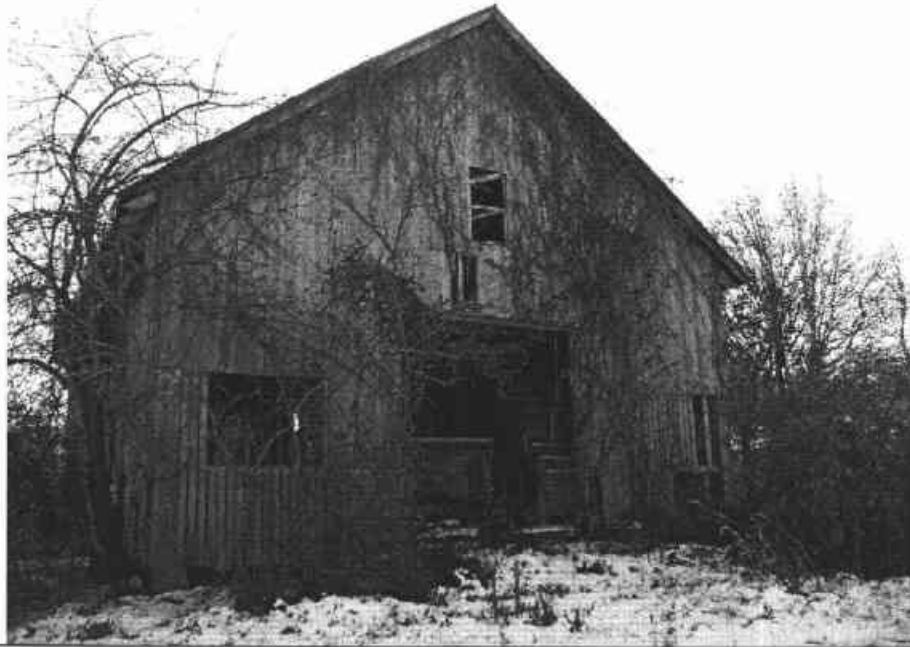
N05196. Photograph 7: Corncrib/granary, north elevation, view to southeast. Note missing wood planks and overgrown vegetation.

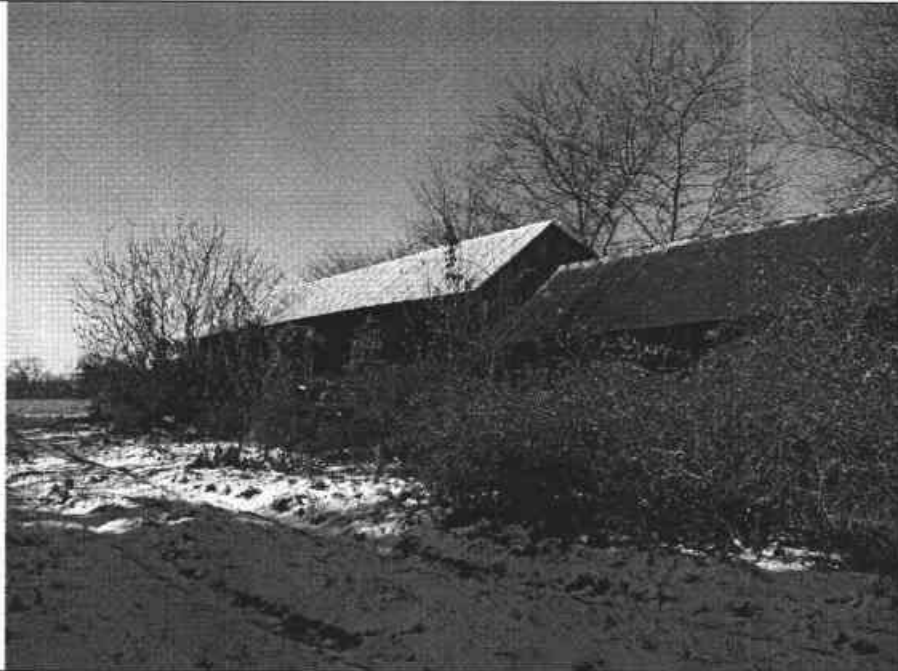
N05196. Photograph 8: Cart shed, south elevation, view to northwest.

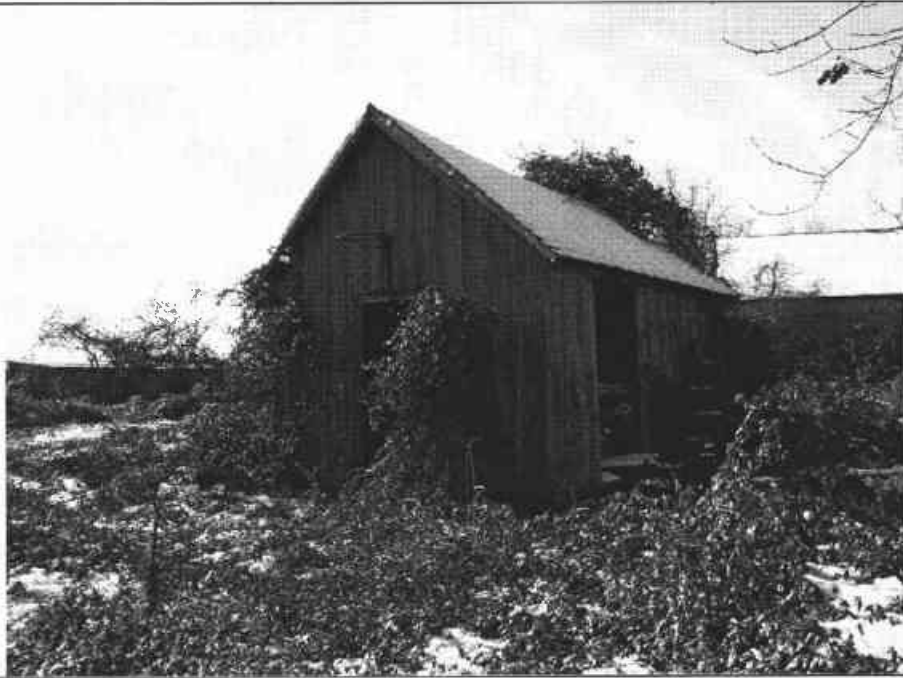
N05196. Photograph 9: Smokehouse, east and north elevations, view to southwest. Note missing door and siding.

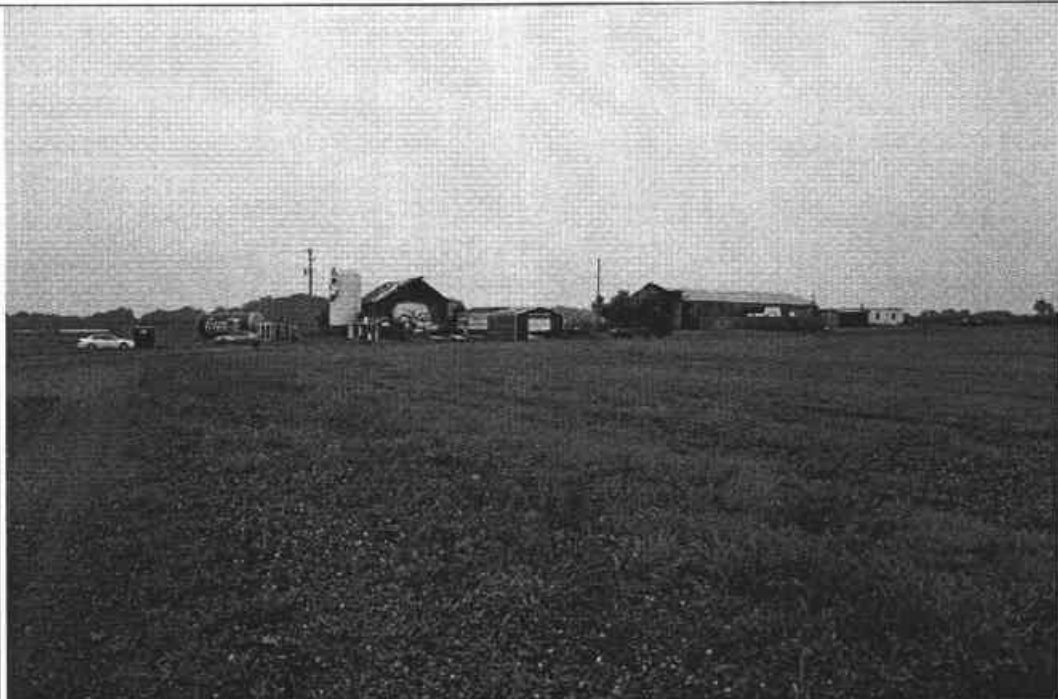
N05198. Photograph 1: Property overview, view to north. Note the modern buildings interspersed between the dairy barn and equipment shed.

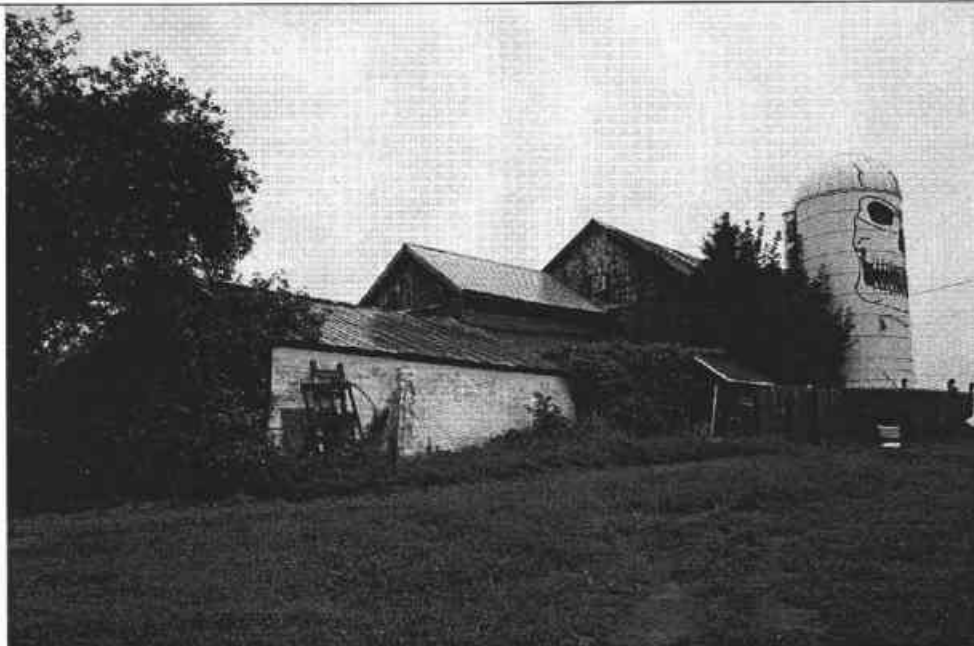
N05198. Photograph 2: Dairy barn, west elevation, view to southeast. Note the barn's additions, the concrete stave silo, and modern wood fencing. The milkhouse is centrally located in the photograph.

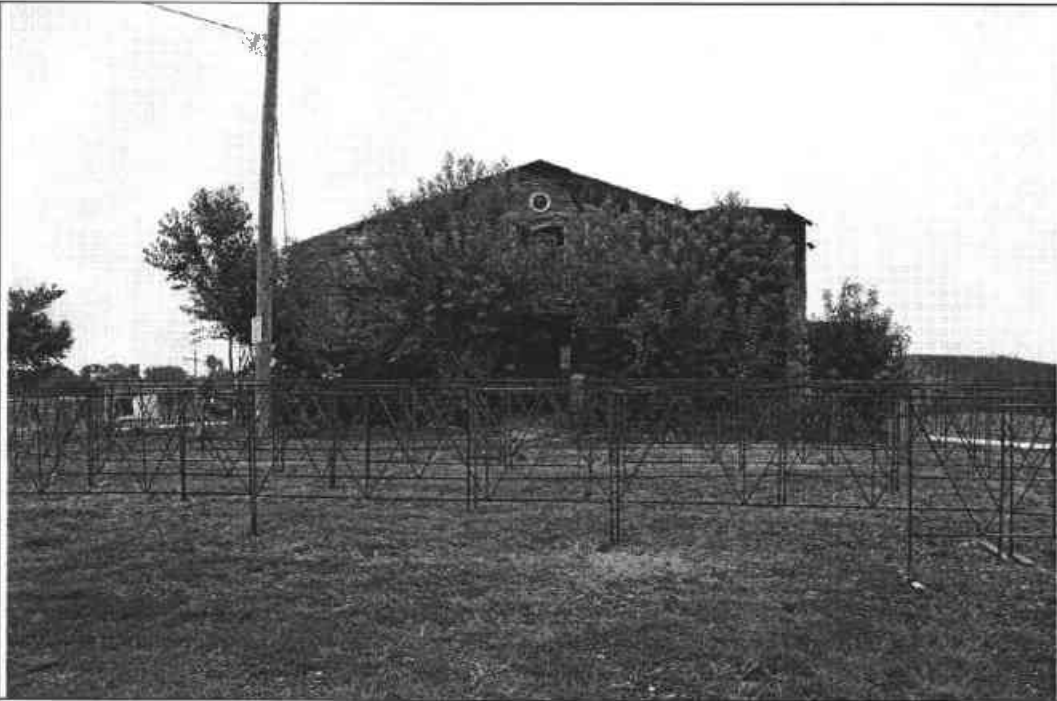
**N05198. Photograph 3: Equipment shed, west elevation, view to east. Trees partially obscure the equipment shed's false front. Note the metal stanchions.**

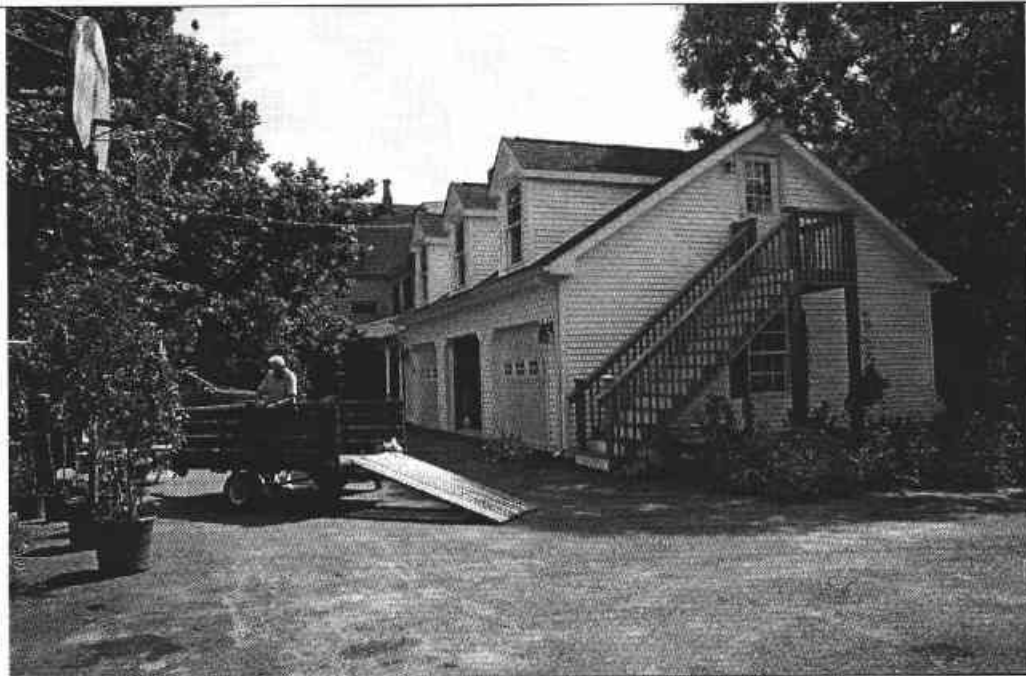
N05208. Photograph 2: Dwelling, north and east elevations, view to southwest. Note modern garage and garage-apartment additions

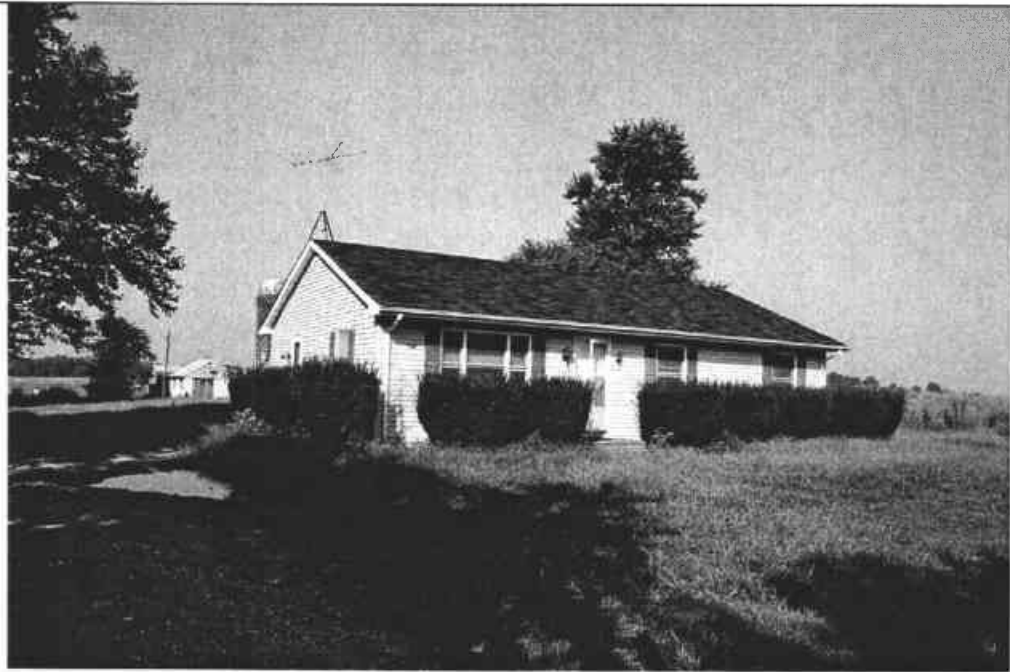
N05218. Photograph 1: Dwelling, east and south elevations, view looking northwest. This is the modern ranch style dwelling located in approximately the same place as the original farmhouse.

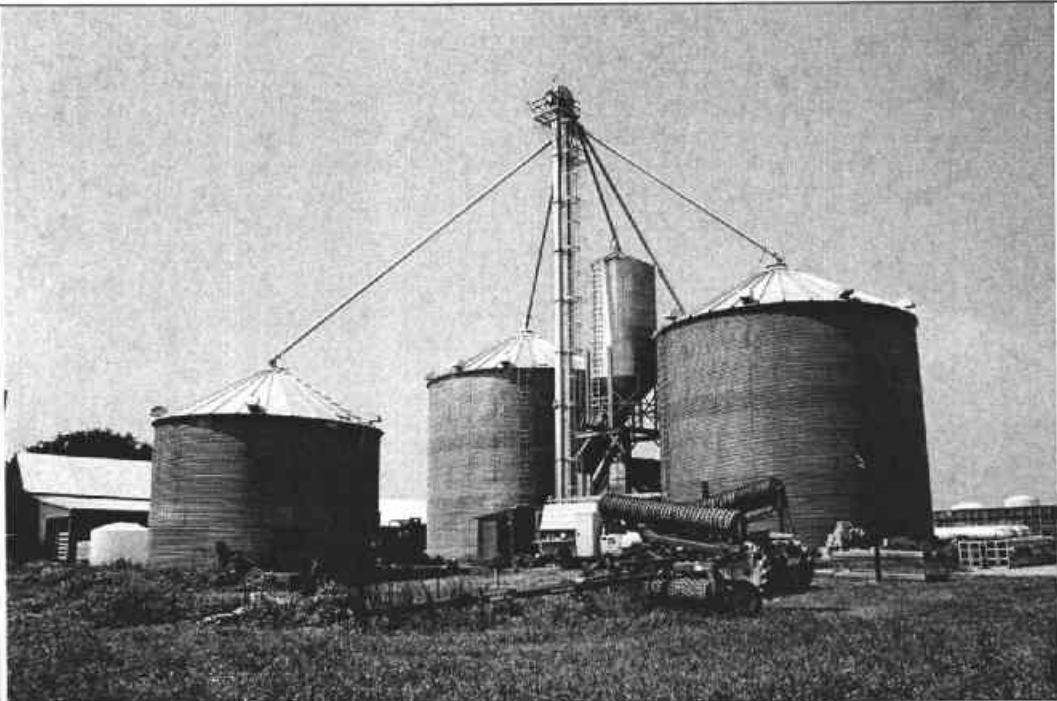
N05224. Photograph 5: Grain drying bins, view looking northeast.

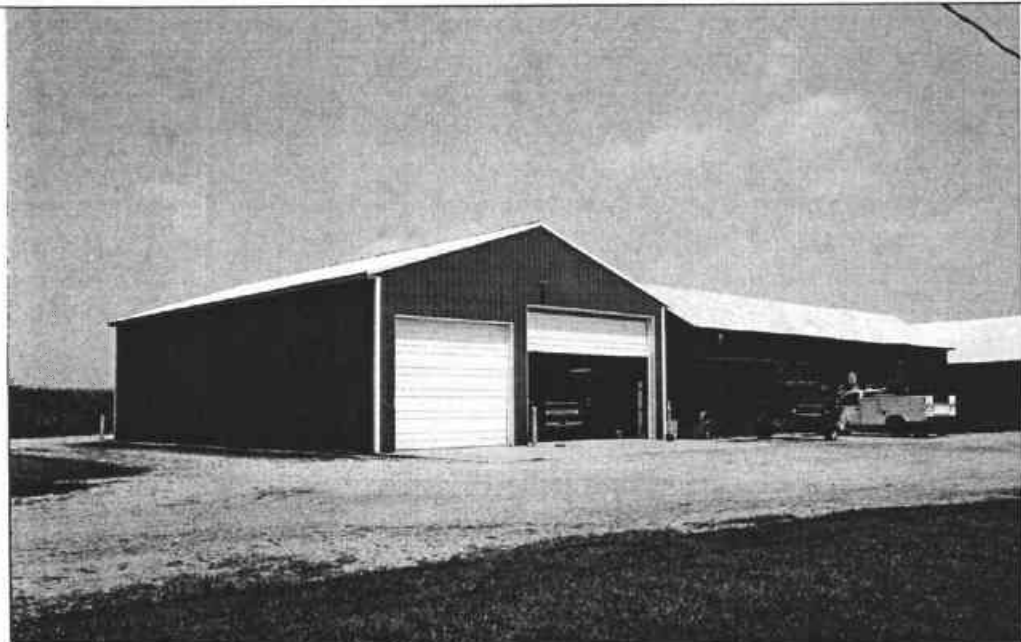
N05224. Photograph 6: Shop/machine shed, west and south elevations, view looking northeast. Note use of corncrib/granary doors at south elevation of central block.

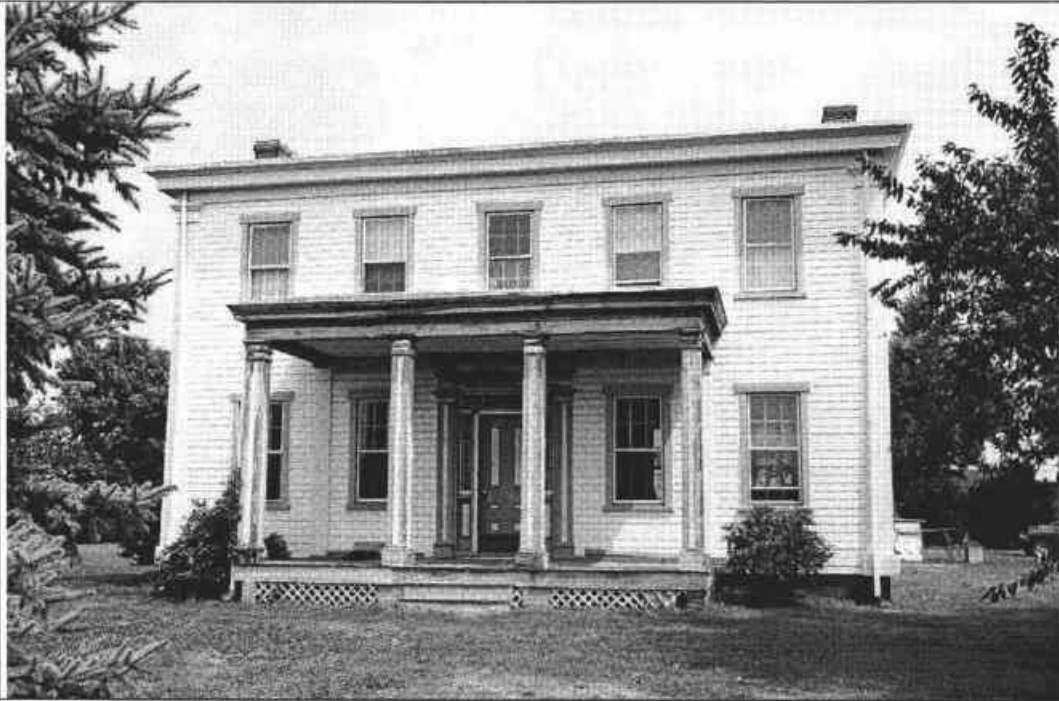
N05225. Photograph 1: Dwelling, façade, view to east. Note Greek Revival porch, corner boards, and door surround.

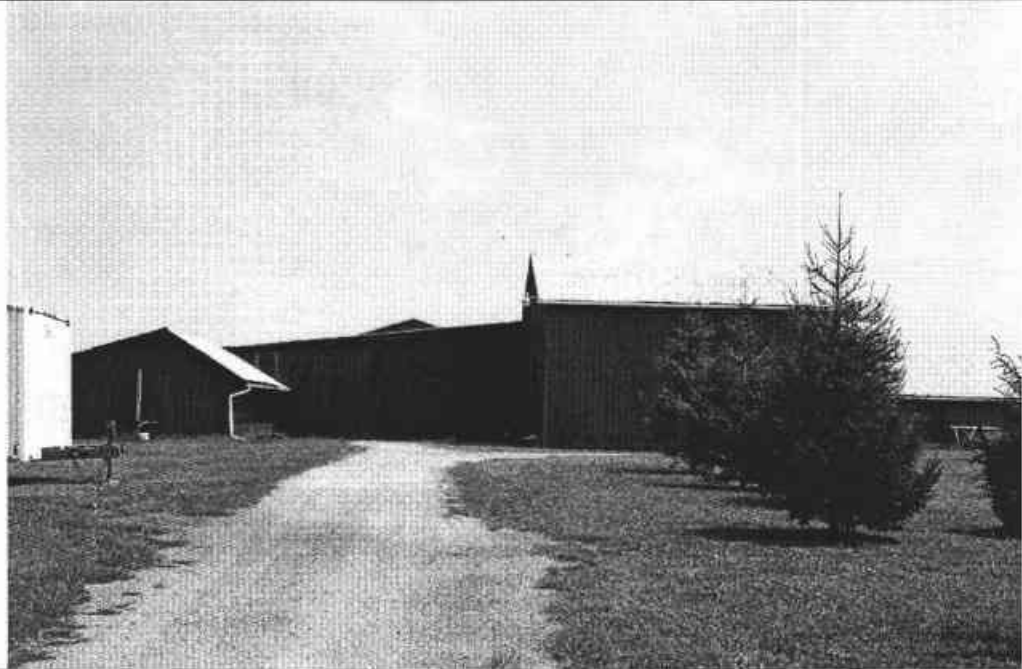
N05225. Photograph 4: Overview of horse barn complex, view to northwest. Note horse barn and open pole shed addition to right.
